**Flood Control Project Maintenance
Levee Inspections**

Maintenance Issue Types Only, Levee Inspection Report By Mile - Spring 2018

Reclamation District No. 0307 Lisbon

Waterway	Bank	Unit Miles	Inspection Start/End	Inspector
Unit No. 01 Sacramento River	Right	6.56	03/06/2018 03/06/2018	Dave Torres

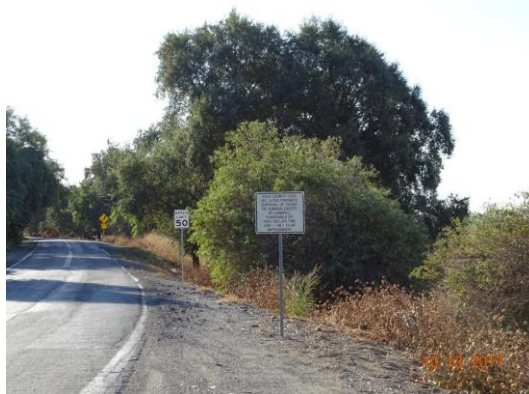
Photo 1 of 1 : SP_2018_RD0307_166_61_20180301_00035.jpg

LM Start	0.01	Rating **	U	Issue No.	61
LM End	0.22	Issue Type +	Ma	Location *	LS
Category	Earthen Levee		GPS Latitude/Longitude		
			Start	End	
Item	Vegetation		38.479953 °	38.477806 °	
			-121.549427 °	-121.546679 °	
DWR ID	DWR_RD0307_01_f_2017_61				
Comment Code					
V2 : Remove the wild growth other than native grasses from the levee slopes.					
Inspector Comment

Landside vegetation should be reduced and maintained to allow inspection and access to slope and toe.

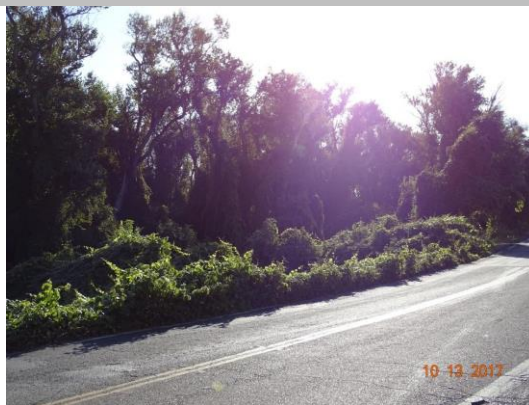
Photo 1 of 1 : SP_2018_RD0307_166_60_20180301_00034.jpg

LM Start	0.01	Rating **	U	Issue No.	60
LM End	0.23	Issue Type +	Ma	Location *	WS
Category	Earthen Levee			GPS Latitude/Longitude	
				Start	End
Item	Vegetation			38.479912 °	38.477725 °
				-121.549293 °	-121.546511 °
DWR ID	DWR_RD0307_01_f_2017_60				
Comment Code					
V2 : Remove the wild growth other than native grasses from the levee slopes.					
Inspector Comment

Waterside vegetation should be trimmed to 20 feet from crown to allow inspection.

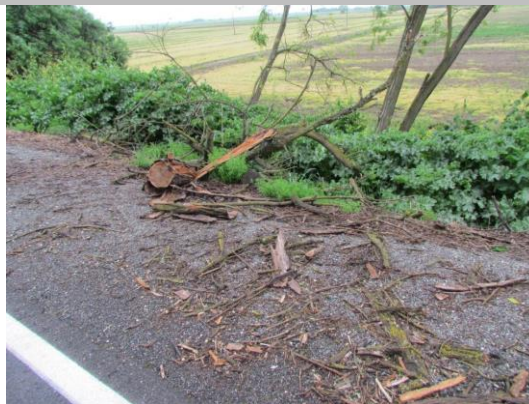
Photo 1 of 1 : SP_2018_RD0307_166_55_20180301_00027.jpg

LM Start	0.09	Rating **	M	Issue No.	55
LM End	0.09	Issue Type +	Ma	Location *	LS
Category	Earthen Levee			GPS Latitude/Longitude	
				Start	End
Item	Encroachments			38.479060 °	38.479060 °
				-121.548418 °	-121.548418 °
DWR ID	DWR_RD0307_01_s_2017_55				
Comment Code					
TR : Tree or limb					
Inspector Comment					
Remove the cut up fallen tree from the land side levee section.

RD 307 Levee mile 0.09 landside fallen tree on the slope and shoulder.

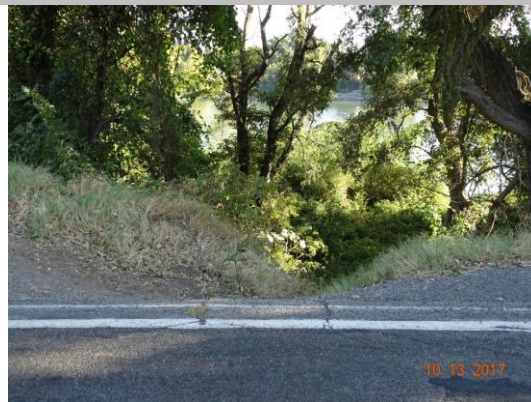
Photo 1 of 1 : SP_2018_RD0307_166_66_20180301_00037.jpg

LM Start	0.20	Rating **	M	Issue No.	66
LM End	0.20	Issue Type +	Ma	Location *	WS
Category	Earthen Levee			GPS Latitude/Longitude	
				Start	End
Item	Slope Stability			38.477977 °	38.477977 °
				-121.546914 °	-121.546914 °
DWR ID	DWR_RD0307_01_f_2017_66				
Comment Code					
S2 : Repair the levee slope damaged by foot traffic and prevent access where possible.					
Inspector Comment					
Foot traffic on waterside slope.

Slope erosion should be repaired and foot traffic stopped.

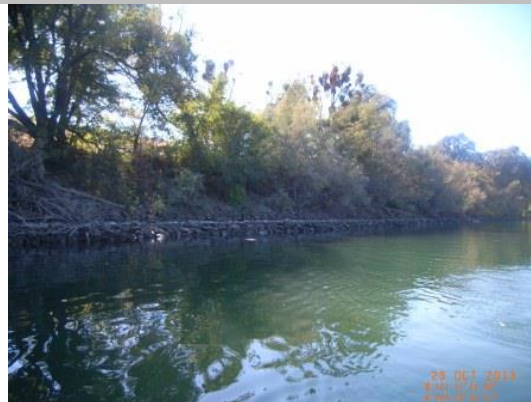
Photo 1 of 1 : SP_2018_RD0307_166_1_20180301_00001.jpg

LM Start	1.17	Rating **	M	Issue No.	1
LM End	1.31	Issue Type +	Ma	Location *	WS
Category	Supplemental			GPS Latitude/Longitude	
				Start	End
Item	2015 USACE Erosion Survey, DRAFT			38.473059 °	38.473082 °
				-121.530988 °	-121.528437 °
DWR ID	DWR_RD0307_01_s_2016_1				
Comment Code					
Inspector Comment					
2012 - Bank is slowly eroding, old rock protection starting to unravel. 2015: No observed changes. [2015 Site ID: SAC_48-6_R]

USACE 2013 Photo #1

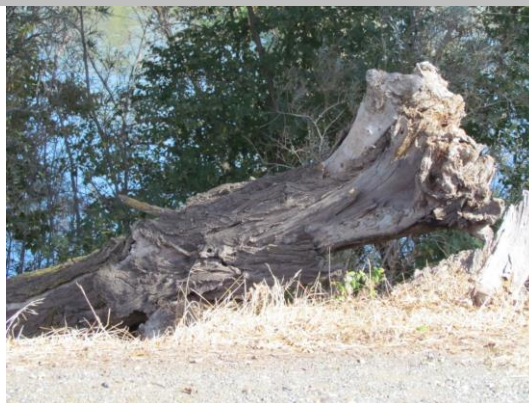
Photo 1 of 1 : SP_2018_RD0307_166_9_20180301_00004.jpg

LM Start	1.29	Rating **	U	Issue No.	9
LM End	1.29	Issue Type +	Ma	Location *	WS
Category	Earthen Levee			GPS Latitude/Longitude	
				Start	End
Item	Encroachments			38.472827 °	38.472827 °
				-121.528785 °	-121.528785 °
DWR ID	DWR_RD0307_01_f_2014_9				
Comment Code					
TR : Tree or limb					
Inspector Comment					
Remove downed trees from waterside slope.

This tree needs to be removed from the waterside slope. No change 4-17.

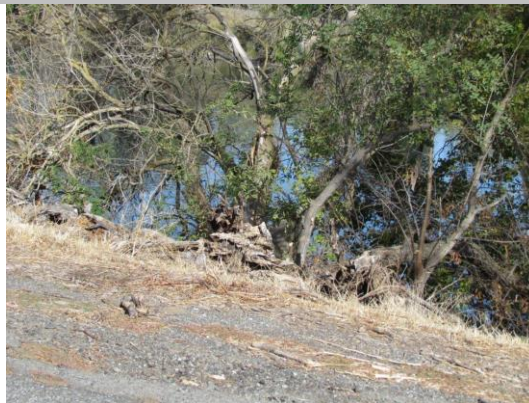
Photo 1 of 1 : SP_2018_RD0307_166_10_20180301_00005.jpg

LM Start	1.35	Rating **	M	Issue No.	10
LM End	1.35	Issue Type +	Ma	Location *	WS
Category	Earthen Levee			GPS Latitude/Longitude	
				Start	End
Item	Encroachments			38.472880 °	38.472880 °
				-121.527733 °	-121.527733 °
DWR ID	DWR_RD0307_01_f_2014_10				
Comment Code					
TR : Tree or limb					
Inspector Comment					
The RD will schedule to have these trees cut up and removed from the waterside levee section as soon as possible. Trees still present during Spring inspection.

Remove unwanted trees from waterside slope. These trees are dead and are resting on the slope. No change 4-17.

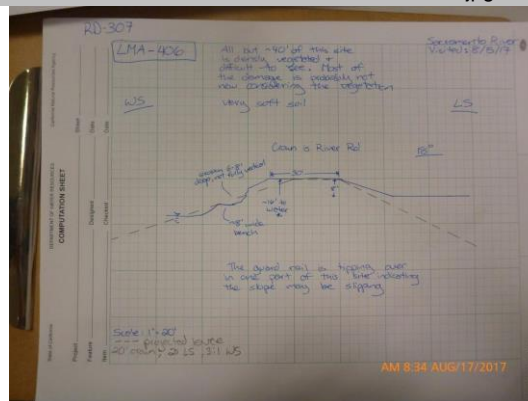
Photo 3 of 3 : LEVAL_SP_2018_500_4226.jpg

LM Start	2.47	Rating **	M	Issue No.	49 (cont)
LM End	2.53	Issue Type +	Ma	Location *	
Category	Supplemental		GPS Latitude/Longitude		
			Start	End	
Item	2017 Storm Damage		38.470583 °	38.470052 °	
			-121.507658 °	-121.506902 °

Description: Slope protection repairs are needed along the waterside slope due to erosion and riprap displacement from high water. Based upon levee inspections, it was determined the waterside levee slope is eroding, deteriorating, and degrading. The eroded levee sections need to be restored back to design standards to prevent further deterioration and damage.

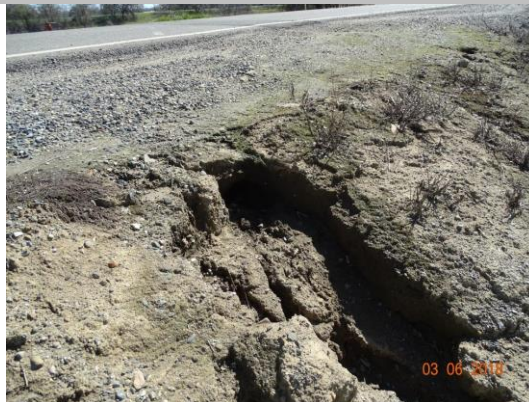
Photo 1 of 2 : SP_2018_RD0307_166_128_20180308_00143.jpg

LM Start	3.98	Rating **	M	Issue No.	128
LM End	3.98	Issue Type +	Ma	Location *	LS
Category	Earthen Levee			GPS Latitude/Longitude	
				Start	End
Item	Erosion / Bank Caving			38.449404 °	38.449404 °
				-121.502663 °	-121.502663 °
DWR ID	DWR_RD0307_01_s_2018_128				
Comment Code					
E1 : Note and monitor erosion site.					
Inspector Comment					
Repair rills on landside slope. Additionally repair rodent holes along this stretch.

Erosion rodent hole landside looking east.

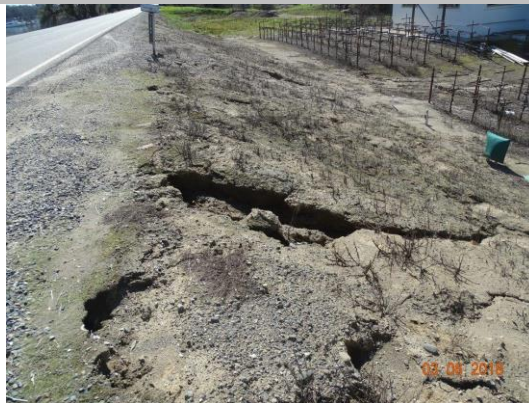
Photo 2 of 2 : SP_2018_RD0307_166_128_20180308_00144.jpg

LM Start	3.98	Rating **	M	Issue No.	128 (cont)	
LM End	3.98	Issue Type +	Ma	Location *	LS	
Category	Earthen Levee			GPS Latitude/Longitude		
				Start		End
Item	Erosion / Bank Caving			38.449404 °		38.449404 °
				-121.502663 °		-121.502663 °
DWR ID	DWR_RD0307_01_s_2018_128					
Comment Code						
E1 : Note and monitor erosion site.						
Inspector Comment						
Repair rills on landside slope. Additionally repair rodent holes along this stretch.

Erosion rodent hole landside looking south.

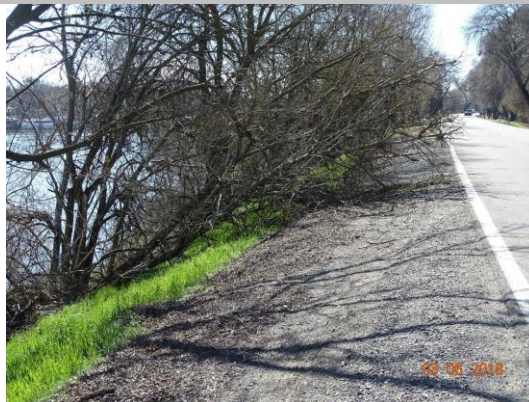
Photo 1 of 1 : SP_2018_RD0307_166_119_20180308_00142.jpg

LM Start	4.11	Rating **	U	Issue No.	119
LM End	4.11	Issue Type +	Ma	Location *	WS
Category	Earthen Levee			GPS Latitude/Longitude	
				Start	End
Item	Encroachments			38.447538 °	38.447538 °
				-121.502659 °	-121.502659 °
DWR ID	DWR_RD0307_01_s_2018_119				
Comment Code					
TR : Tree or limb					
Inspector Comment					
Downed tree on waterside slope.

Downed tree waterside looking south.

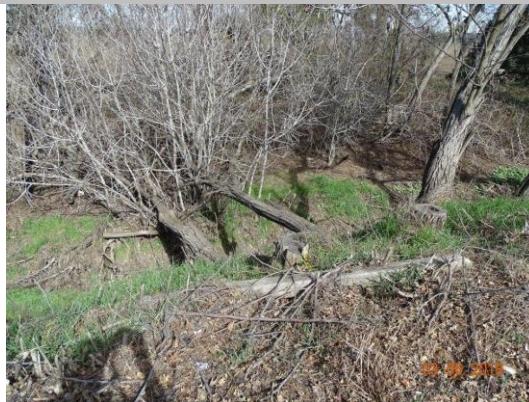
Photo 1 of 1 : SP_2018_RD0307_166_104_20180308_00139.jpg

LM Start	4.88	Rating **	M	Issue No.	104
LM End	4.88	Issue Type +	Ma	Location *	LS
Category	Earthen Levee			GPS Latitude/Longitude	
				Start	End
Item	Encroachments			38.437871 °	38.437871 °
				-121.508356 °	-121.508356 °
DWR ID	DWR_RD0307_01_s_2018_104				
Comment Code					
TR : Tree or limb					
Inspector Comment					
Downed tree on landside slope.

Encroachment downed tree on landside looking south

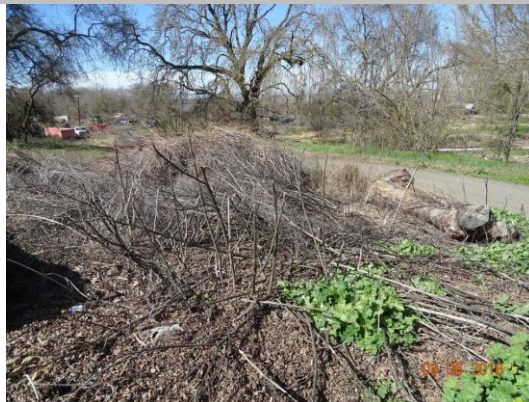
Photo 1 of 1 : SP_2018_RD0307_166_114_20180308_00141.jpg

LM Start	6.15	Rating **	U	Issue No.	114
LM End	6.15	Issue Type +	Ma	Location *	LS
Category	Earthen Levee			GPS Latitude/Longitude	
				Start	End
Item	Vegetation			38.435118 °	38.435118 °
				-121.530795 °	-121.530795 °
DWR ID	DWR_RD0307_01_s_2018_114				
Comment Code					
V2 : Remove the wild growth other than native grasses from the levee slopes.					
Inspector Comment

Vegetation landside looking southwest.

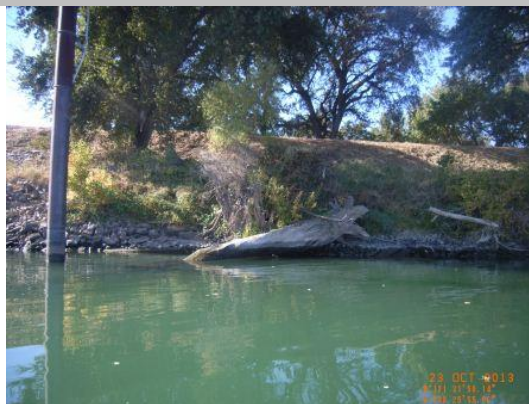
Photo 1 of 1 : SP_2018_RD0307_166_2_20180301_00002.jpg

LM Start	6.19	Rating **	M	Issue No.	2
LM End	6.38	Issue Type +	Ma	Location *	WS
Category	Supplemental			GPS Latitude/Longitude	
				Start	End
Item	2015 USACE Erosion Survey, DRAFT			38.434560 °	38.432287 °
				-121.531159 °	-121.532978 °
DWR ID	DWR_RD0307_01_s_2016_2				
Comment Code					
Inspector Comment					
2008 - Large rotational failure in bank and well into the levee slope. Could be a significant problem in the next high flow event. 2009 - Minimal new erosion, site extended upstream. 2010 - Minor new erosion. 2011 - Tree popout has left a large hole. Large slump area. Rock on the bank is failing in some locations. 2012 - The toe appears to be scouring out. 2015: No observed changes. [2015 Site ID: SAC_43-2_R]

USACE 2013 Photo #1

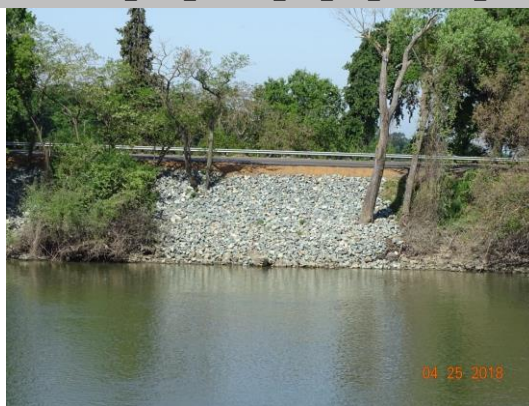
Photo 1 of 2 : SP_2018_RD0307_166_107_20180425_00145.jpg

LM Start	6.42	Rating **	A/W	Issue No.	107		
LM End	6.55	Issue Type +	Ma	Location *			
Category	Earthen Levee			GPS Latitude/Longitude			
				Start		End	
Item	Erosion / Bank Caving				o		o
					o		o
DWR ID	DWR_RD0307_01_s_2018_107						
Comment Code							
Inspector Comment							
This is to identify corrections to the USACE 2015 Erosion survey. The LMA repaired erosion sites in 2017.

RD307 Lisbon Unit 1 Issue 107 LM6.42-6.55 Erosion repaired picture taken from LB looking west.

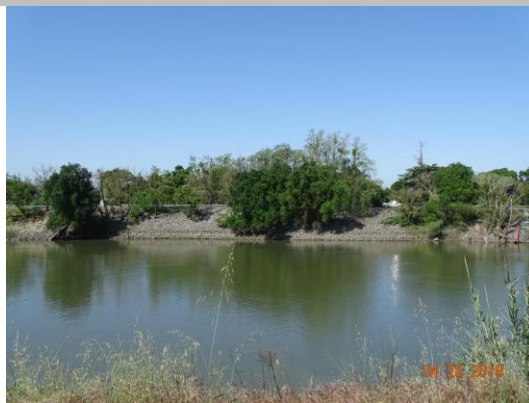
Photo 2 of 2 : SP_2018_RD0307_166_107_20180425_00146.jpg

LM Start	6.42	Rating **	A/W	Issue No.	107 (cont)		
LM End	6.55	Issue Type +	Ma	Location *			
Category	Earthen Levee			GPS Latitude/Longitude			
				Start		End	
Item	Erosion / Bank Caving				°		°
					°		°
DWR ID	DWR_RD0307_01_s_2018_107						
Comment Code							
Inspector Comment							
This is to identify corrections to the USACE 2015 Erosion survey. The LMA repaired erosion sites in 2017.

RD307 Lisbon Unit 1 Issue 107 LM6.42-6.55 Erosion repaired picture taken from LB looking west.

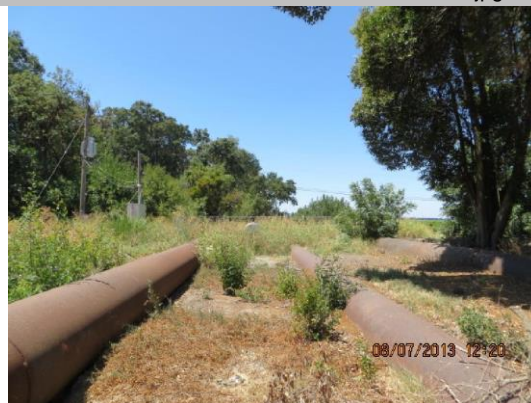
Photo 1 of 3 : UCIP_SP_2018_17406_29510.jpg

LM Start	6.54	Rating **	A/W	Issue No.	161
LM End	6.54	Issue Type +	Ma	Location *	
Category	Supplemental			GPS Latitude/Longitude	
				Start	End
Item	DWR UCIP LMA Responsibility			38.430043 °	38.430043 °
				-121.533275 °	-121.533275 °
DWR ID					
Comment Code					
Inspector Comment					
FS_ID:17406					
DS_ID:21731					
EP_NO: N/A					
Repair Type: No Action Needed					
Crossing Status: Found					
UCIP Comments:					
FIELD_STRUCT_DESC: 2 of 2: 36-inch steel drainage pipe through the					
levee, 16 feet below the crown. Flap gate on the waterside (WS) end.					
Gate valve and air vent on the landside (LS). Pump and trash rack 200					
feet off the LS toe. [Additional Reference(s): DWR Levee Log, 1990.					
USACE Sacramento O&M Manual 114, April 1959, (RM 43.08)].					
FS Date: 8/7/2013

Pipes visible on LS toe.

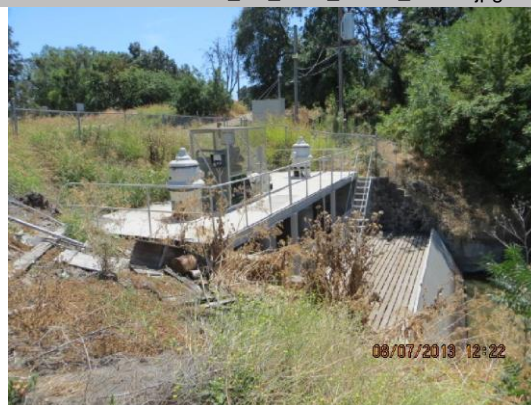
Photo 2 of 3 : UCIP_SP_2018_17406_29509.jpg

Pump and trash rack 200-feet off LS toe.

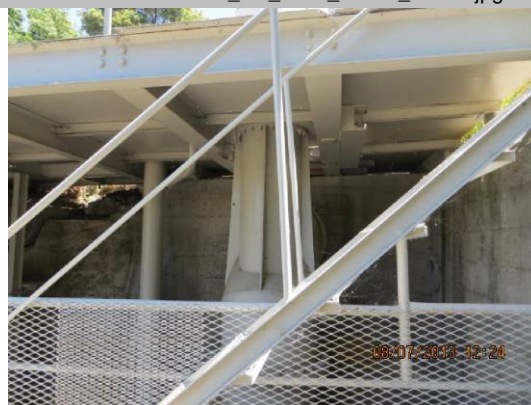
Photo 3 of 3 : UCIP_SP_2018_17406_29508.jpg

LM Start	6.54	Rating **	A/W	Issue No.	161 (cont)	
LM End	6.54	Issue Type +	Ma	Location *		
Category	Supplemental			GPS Latitude/Longitude		
				Start		End
Item	DWR UCIP LMA Responsibility			38.430043 °		38.430043 °
				-121.533275 °		-121.533275 °
DWR ID						
Comment Code						
Inspector Comment						
FS_ID:17406						
DS_ID:21731						
EP_NO: N/A						
Repair Type: No Action Needed						
Crossing Status: Found						
UCIP Comments:						
FIELD_STRUCT_DESC: 2 of 2: 36-inch steel drainage pipe through the						
levee, 16 feet below the crown. Flap gate on the waterside (WS) end.						
Gate valve and air vent on the landside (LS). Pump and trash rack 200						
feet off the LS toe. [Additional Reference(s): DWR Levee Log, 1990.						
USACE Sacramento O&M Manual 114, April 1959, (RM 43.08)].						
FS Date: 8/7/2013

Intake at concrete headwall under pump.
